## Penetrant test report

**Report number** LW26-0253-04 PT  
**Customer name** AAS STEEL PTY LTD  
**Address** 9 Trade Place Pakenham VIC Australia 3810  
**Requested by** Shan Senn

**Job description** Visible dye penetrant testing on 350NB header weldments  
**Identification** Job: VMM00120 NEXT DC M3 STAGE 2; Drawing: SDRG-B-0201-8241

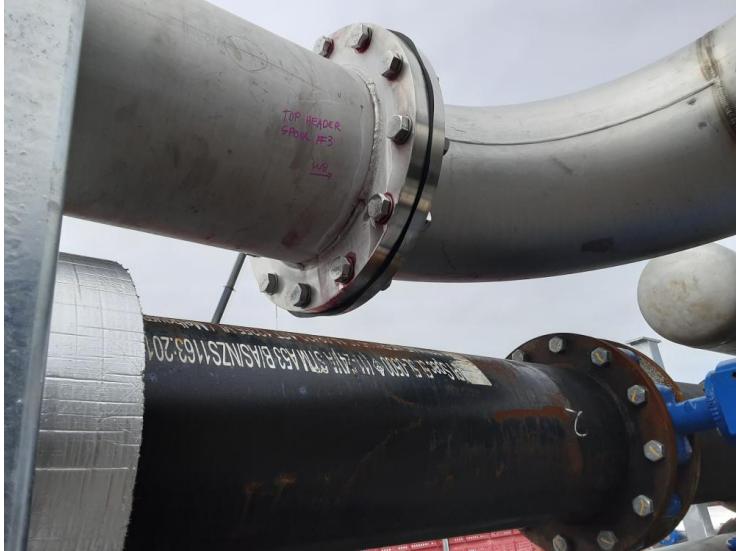
Image 1 of 7 - Spool #3 welds 8

| Identification | Spool No. | Weld No. | Description | Test area | Discontinuities |
|---|---|---|---|---|---|
| North end | Spool 3 | 8 | Top header | Entire facing south | LS20 @ 1ocl |

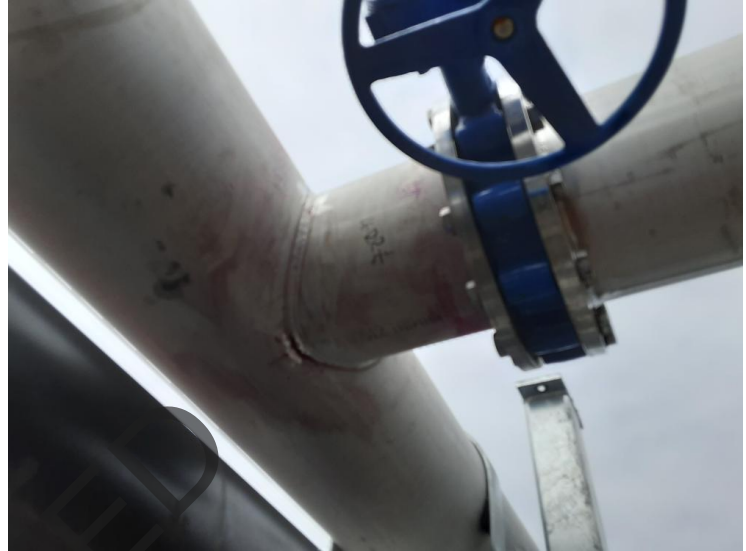
Image 2 of 7 - Spool #3 welds 6 & 7

| Identification | Spool No. | Weld No. | Description | Test area | Discontinuities |
|---|---|---|---|---|---|
| North end | Spool 3 | 6 | Top header | Entire facing east | LS50 @ 6ocl, LS15 @ 9ocl, CC10 @ 3ocl, LS40 @ 12ocl |
| North end | Spool 3 | 7 | Top header | Entire facing west | IN5 @ 1ocl, LS40 @ 6ocl |

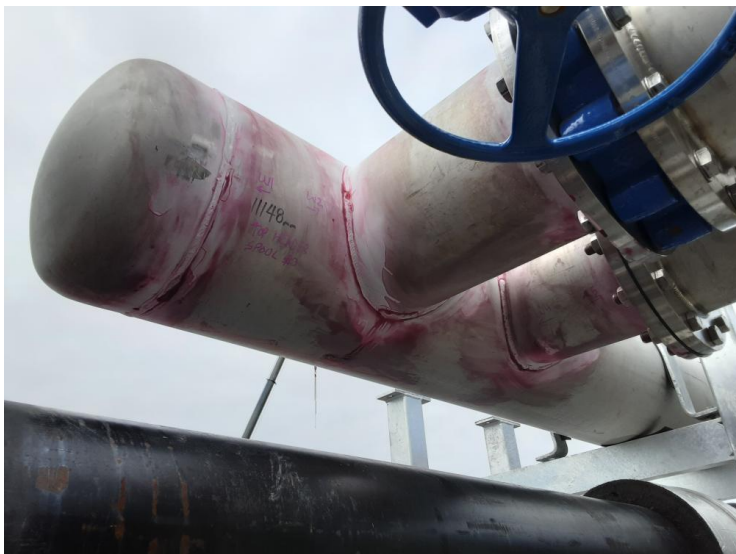
Image 3 of 7 - Spool #3 welds 1-5

| Identification | Spool No. | Weld No. | Description | Test area | Discontinuities |
|---|---|---|---|---|---|
| North end | Spool 3 | 1 | Top header | 5-1 o'clock facing north | LS25 @ 12ocl, GP1 @ 12ocl, LS80 @ 11ocl, LS20 @ 9ocl, LS200 @ 6ocl |
| North end | Spool 3 | 2 | Top header | Entire facing east | CC5 @ 3ocl, GP1 @ 12ocl, LS80 @ 12ocl, LS80 @ 6ocl, CC10 @ 9ocl, LS10 @ 9ocl |
| North end | Spool 3 | 3 | Top header | Entire facing west | LS30 & excessive cap @ 9ocl, 2 off LS30 6ocl |
| North end | Spool 3 | 4 | Top header | Entire facing east | LS100 @ 6ocl, CC3 @ 3ocl, GP1 @ 4ocl, LS40 @ 12ocl, 2 off GP1 @ 12 |
| North end | Spool 3 | 5 | Top header | Entire facing west | LS50 @ 12ocl, CC5 @ 11ocl |

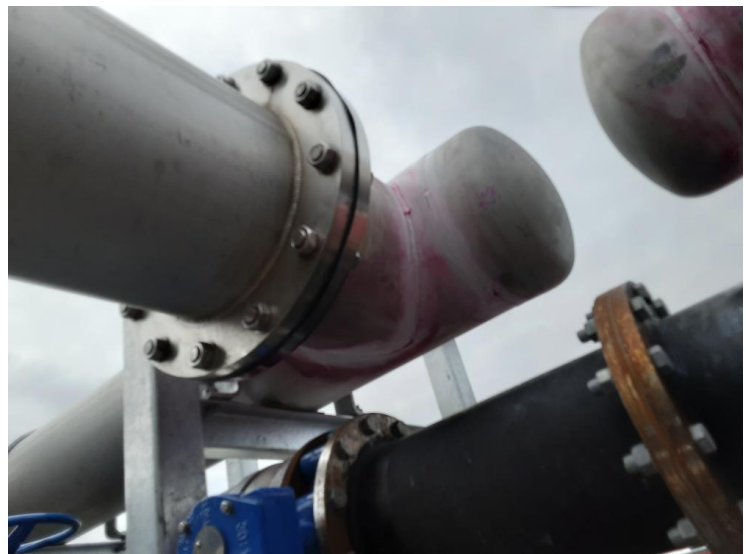
Image 4 of 7 - Spool #2 weld 4-6

| Identification | Spool No. | Weld No. | Description | Test area | Discontinuities |
|---|---|---|---|---|---|
| North end | Spool 2 | 4 | Top header | Entire facing east | LS100 @ 12ocl, LS10 @ 3ocl, LS100 @ 12ocl, GP1 @ 7ocl |
| North end | Spool 2 | 5 | Top header | Entire facing west | LS10 @ 12ocl, LS20 @ 9ocl, LS30 @ 5ocl, LS20 & LS14 @ 6ocl, IN5 @ 2ocl |
| North end | Spool 2 | 6 | Top header | 11-7 o'clock facing south | IN10 @ 12ocl, GP2 @ 3ocl, LS20 @ 6ocl |

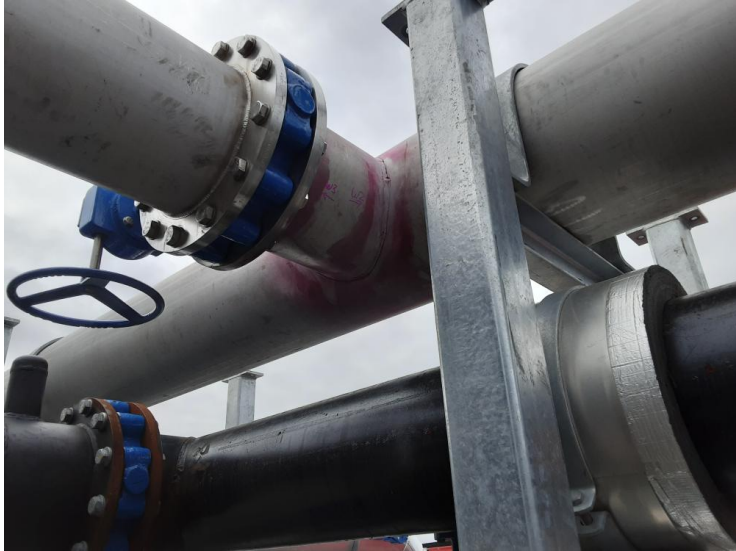
Image 5 of 7 - Spool #2 weld 2 & 3

| Identification | Spool No. | Weld No. | Description | Test area | Discontinuities |
|---|---|---|---|---|---|
| North end | Spool 2 | 2 | Top header | Entire facing east | KL5 @ 12ocl, LS10 @ 2ocl, LS25 @ 3ocl, LS15 @ 9ocl, LS20 @ 9ocl, IN3 @ 2ocl |
| North end | Spool 2 | 3 | Top header | Entire facing west | Intermittent LS entire radius |

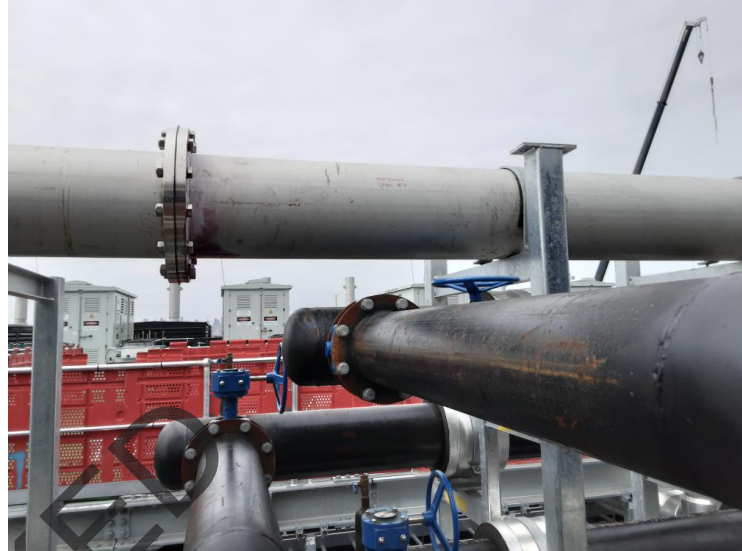
Image 6 of 7 - Spool #2 weld 1

| Identification | Spool No. | Weld No. | Description | Test area | Discontinuities |
|---|---|---|---|---|---|
| North end | Spool 2 | 1 | Top header | 8-1 o'clock facing north | GP 1 @ 12ocl, LS20 @ 12ocl, LS25 @ 12ocl, GP1 @ 9ocl |

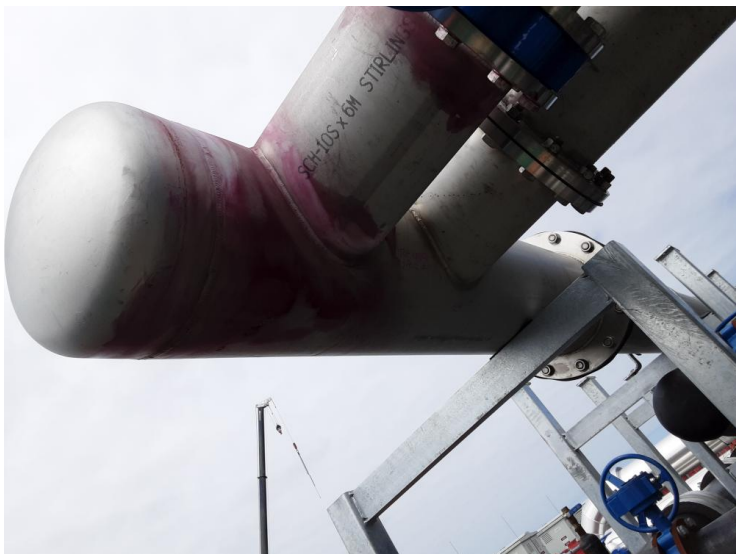
Image 7 of 7 - Spool #1 welds 1-5

| Identification | Spool No. | Weld No. | Description | Test area | Discontinuities |
|---|---|---|---|---|---|
| North end | Spool 1 | 1 | Top header | 7-11 o'clock Facing north | NUSID |
| North end | Spool 1 | 2 | Top header | 5-10 o'clock Facing east | NUSID |
| North end | Spool 1 | 3 | Top header | 2-7 o'clock Facing west | NUSID |
