## Penetrant test report

**Report number** LW26-0253-06 PT  
**Customer name** AAS STEEL PTY LTD  
**Address** 9 Trade Place Pakenham VIC Australia 3810  
**Requested by** Shan Senn

**Job description** Visible dye penetrant testing on 350NB header weldments  
**Identification** Job: VMM00120 NEXT DC M3 STAGE 2; Drawing: SDRG-B-0201-8241

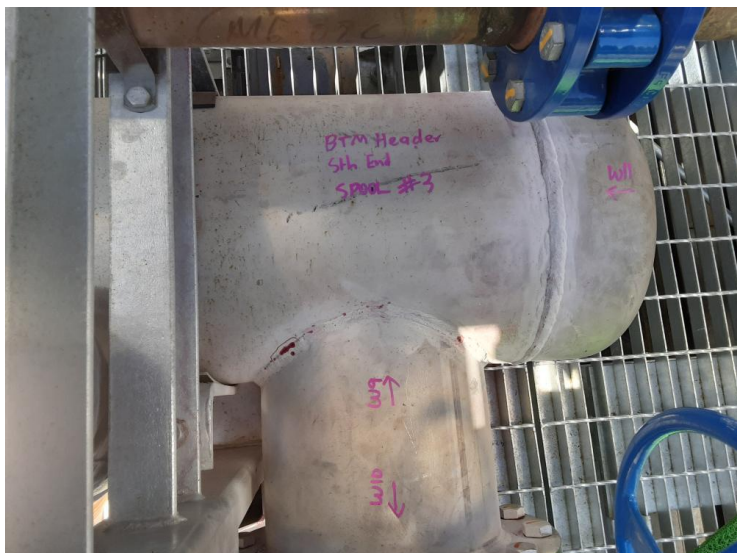
Image 1 of 12 - South end spool #3 W9-11

| Identification | Spool No. | Weld No. | Description | Test area | Discontinuities |
|---|---|---|---|---|---|
| South end | Spool 3 | 9 | Bottom header | 7-5 o'clock Facing east | LS30 @ 11ocl, LS10 @ 1ocl, LS30 @ 3ocl, LS25 @ 6ocl, LS25 @ 5ocl |
| South end | Spool 3 | 10 | Bottom header | 7-5 o'clock Facing west | Uniform porosity, test restriction post masking 3-6 |
| South end | Spool 3 | 11 | Bottom header | 7-5 o'clock Facing south | LS10 @ 9ocl, LS25 @ 4ocl, CC5 @ 4ocl |

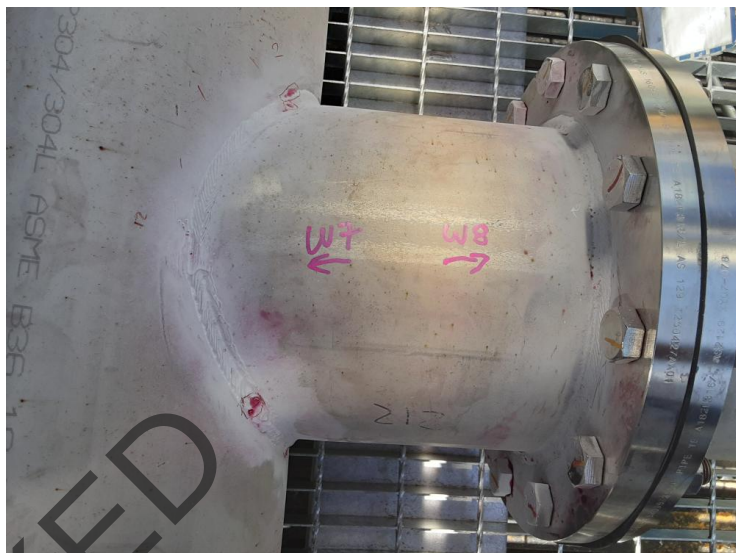
Image 2 of 12 - South end spool #3 W7-8

| Identification | Spool No. | Weld No. | Description | Test area | Discontinuities |
|---|---|---|---|---|---|
| South end | Spool 3 | 7 | Bottom header | 7-5 o'clock Facing east | LS15 @ 2ocl, LS5 @ 2ocl, IN10 @ 10ocl, LS15 @ 9ocl, LS15 @ 8ocl, LS15 @ 7ocl. Uniform porosity |
| South end | Spool 3 | 8 | Bottom header | 7-5 o'clock Facing west | CC15 @ 3ocl, LS15 @ 9ocl, LS30 @ 6ocl |

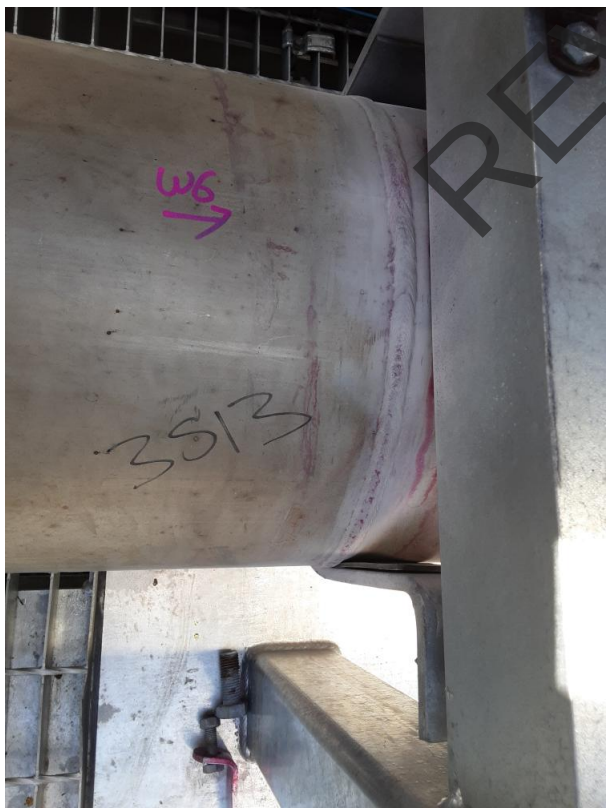
Image 3 of 12 - South end spool #3 W6

| Identification | Spool No. | Weld No. | Description | Test area | Discontinuities |
|---|---|---|---|---|---|
| South end | Spool 3 | 6 | Bottom header | 7-5 o'clock Facing north | NUSID test restriction saddle masking 3-9 o'clock |

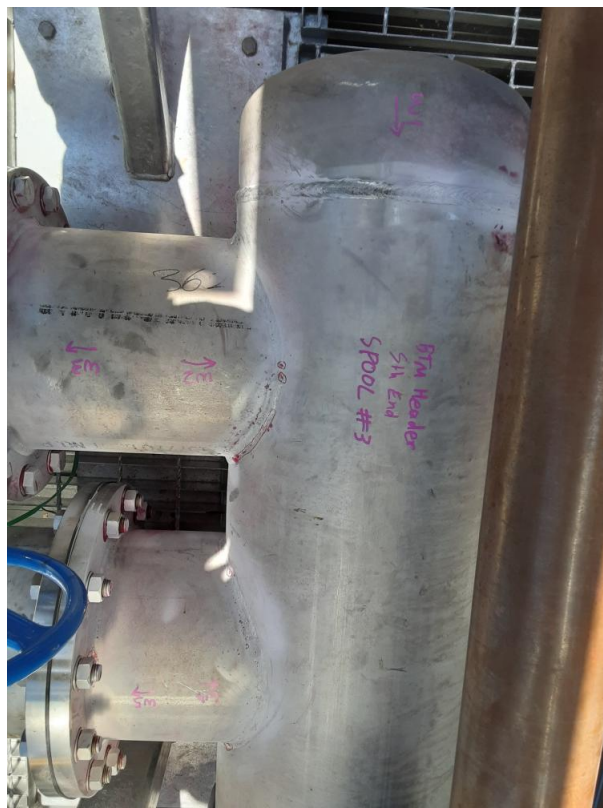
Image 4 of 12 - South end spool #3 W1-5

| Identification | Spool No. | Weld No. | Description | Test area | Discontinuities |
|---|---|---|---|---|---|
| South end | Spool 3 | 1 | Bottom header | 7-5 o'clock Facing north | LS10 @ 9ocl |
| South end | Spool 3 | 2 | Bottom header | 7-5 o'clock Facing east | LS30 @ 6ocl, LS25 @ 7ocl, LS15 @ 9ocl, LS5 @ 12ocl, L3130 @ 2ocl, LS10 @ 3ocl. Uniform porosity |
| South end | Spool 3 | 3 | Bottom header | 7-5 o'clock Facing west | CC15 @ 12ocl, LS15 @ 3ocl, LS10 @ 6ocl, LS20 @ 9ocl |
| South end | Spool 3 | 4 | Bottom header | 7-5 o'clock Facing east | LS25 @ 2ocl, GP2 @ 10ocl. Uniform porosity |
| South end | Spool 3 | 5 | Bottom header | 7-5 o'clock Facing west | CC15 @ 12ocl, LS20 @ 3ocl, LS30 @ 6ocl, LS20 @ 9ocl. Uniform porosity |

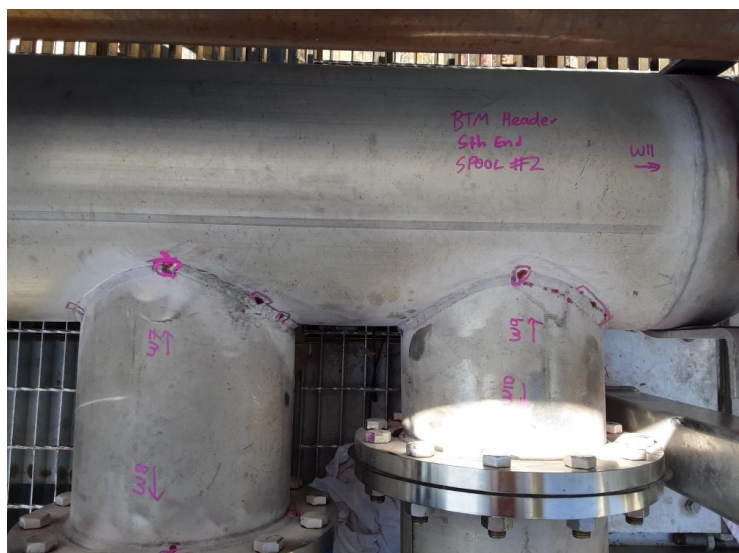
Image 5 of 12 - South end spool #2 W7-11

| Identification | Spool No. | Weld No. | Description | Test area | Discontinuities |
|---|---|---|---|---|---|
| South end | Spool 2 | 7 | Bottom header | 7-5 o'clock Facing east | LS15 @ 12ocl, LS10 @ 10ocl, LS20 @ 9ocl, LS30 @ 8ocl, LS25 @ 6ocl, LS20 @ 3ocl, LS10 @ 2ocl, LS10 @ 1ocl |

| Identification | Spool No. | Weld No. | Description | Test area | Discontinuities |
|---|---|---|---|---|---|
| South end | Spool 2 | 8 | Bottom header | 7-5 o'clock Facing west | LS40 @ 6ocl, LS20 @ 12ocl, LS20 @ 9ocl, LS35 @ 3ocl |
| South end | Spool 2 | 9 | Bottom header | 7-5 o'clock Facing east | LS20 @ 12ocl, LS80 @ 1ocl, LS20 @ 9ocl, LS20 @ 7ocl |
| South end | Spool 2 | 10 | Bottom header | 7-5 o'clock Facing west | CC10 @ 12ocl, LS50 @ 9ocl, LS30 @ 3ocl |
| South end | Spool 2 | 11 | Bottom header | 7-5 o'clock Facing south | LS10 @ 3ocl, CC5 @ 9ocl, LS20 @ 9ocl, LS5 @ 8ocl |

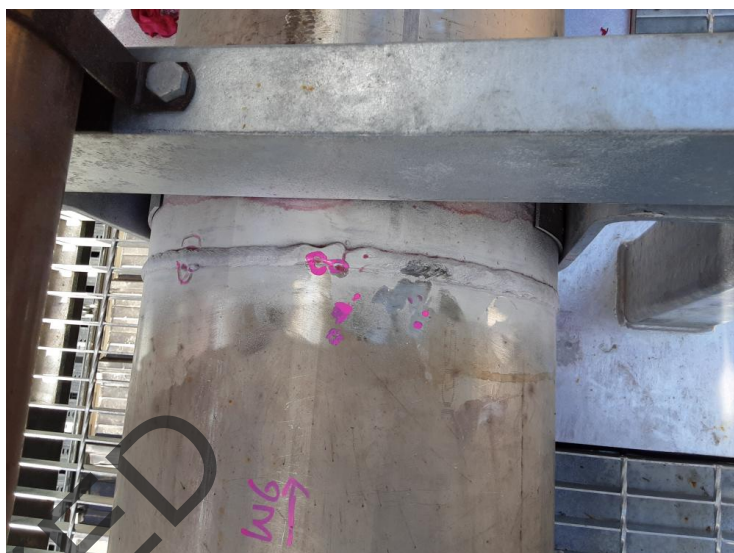
Image 6 of 12 - South end spool #2 W6

| Identification | Spool No. | Weld No. | Description | Test area | Discontinuities |
|---|---|---|---|---|---|
| South end | Spool 2 | 6 | Bottom header | 7-5 o'clock Facing north | LS5 @ 12ocl, LS5 @ 12ocl, LS5 @ 1ocl, LS120 @ 3ocl, LS25 @ 3ocl, LS30 @ 6ocl, LS10 @ 6ocl, LS10 @ 8ocl, LS10 @ 8ocl |

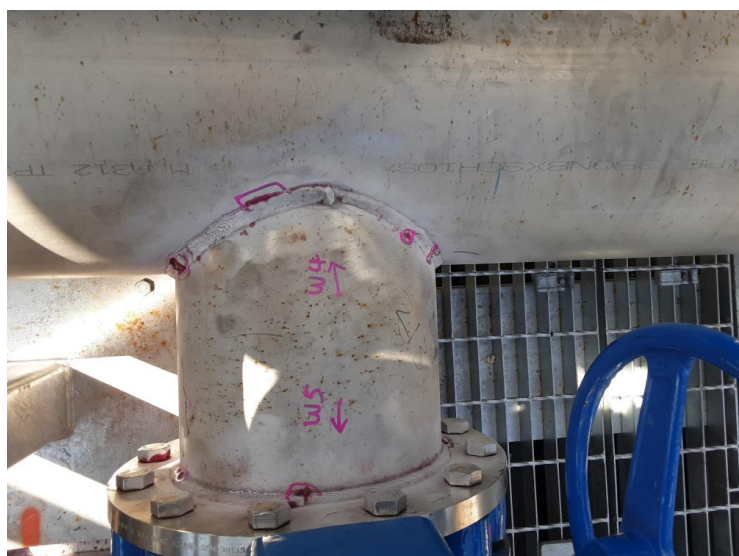
Image 7 of 12 - South end spool #2 W4-5

| Identification | Spool No. | Weld No. | Description | Test area | Discontinuities |
|---|---|---|---|---|---|
| South end | Spool 2 | 4 | Bottom header | 7-5 o'clock Facing west | LS30 @ 6ocl, LS10 @ 1ocl, LS15 @ 2ocl, GP5 @ 3ocl, LS30 @ 8ocl, LS25 @ 9ocl, LS25 @ 10ocl, LS30 @ 11ocl |
| South end | Spool 2 | 5 | Bottom header | 7-5 o'clock Facing east | LS10 @ 12ocl, CC5 @ 2ocl, LS10 @ 2ocl, CC5 @ 5ocl, LS40 @ 5ocl, LS30 @ 9ocl |

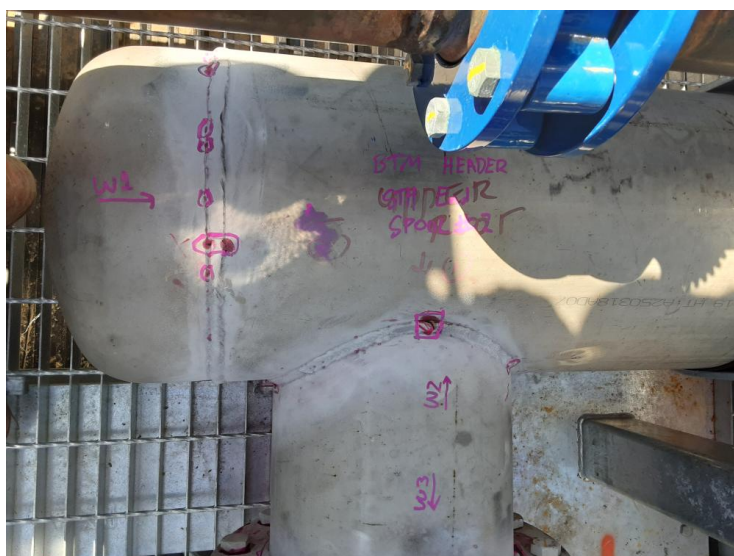
Image 8 of 12 - South end spool #2 W1-3

| Identification | Spool No. | Weld No. | Description | Test area | Discontinuities |
|---|---|---|---|---|---|
| South end | Spool 2 | 1 | Bottom header | 7-5 o'clock Facing north | Intermittent LS 11-6 ocl |
| South end | Spool 2 | 2 | Bottom header | 7-5 o'clock Facing west | LS20 @ 12ocl, LS10 @ 2ocl, LS15 @ 3ocl, LS20 @ 5ocl, LS20 @ 6ocl |
| South end | Spool 2 | 3 | Bottom header | 7-5 o'clock Facing east | CC5 @ 2ocl, LS25 @ 3ocl, LS15 @ 5ocl, LS60 @ 9ocl |

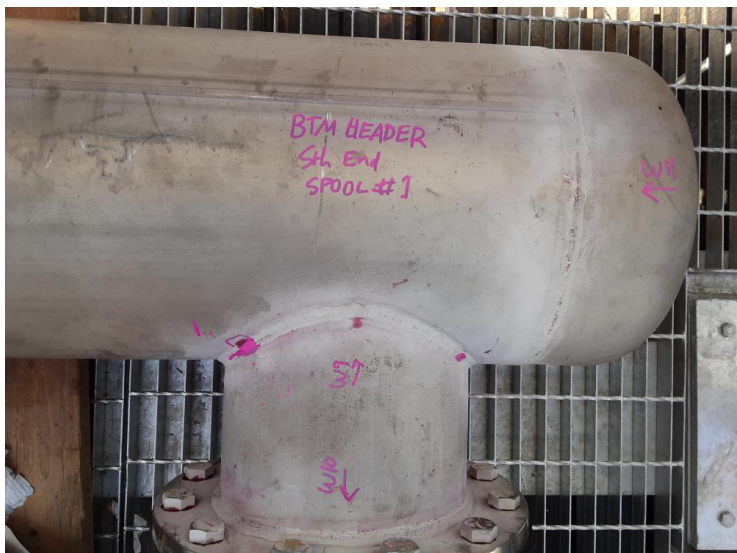
Image 9 of 12 - South end spool #1 W9-11

| Identification | Spool No. | Weld No. | Description | Test area | Discontinuities |
|---|---|---|---|---|---|
| South end | Spool 1 | 9 | Bottom header | 7-5 o'clock Facing west | LS15 @ 11ocl, CC3 @ 2ocl, LS20 @ 7ocl |
| South end | Spool 1 | 10 | Bottom header | 7-5 o'clock Facing east | CC5 @ 7ocl, CC5 @ 3ocl |
| South end | Spool 1 | 11 | Bottom header | 7-5 o'clock Facing south | LS10 @ 9ocl, LS10 @ 5ocl |

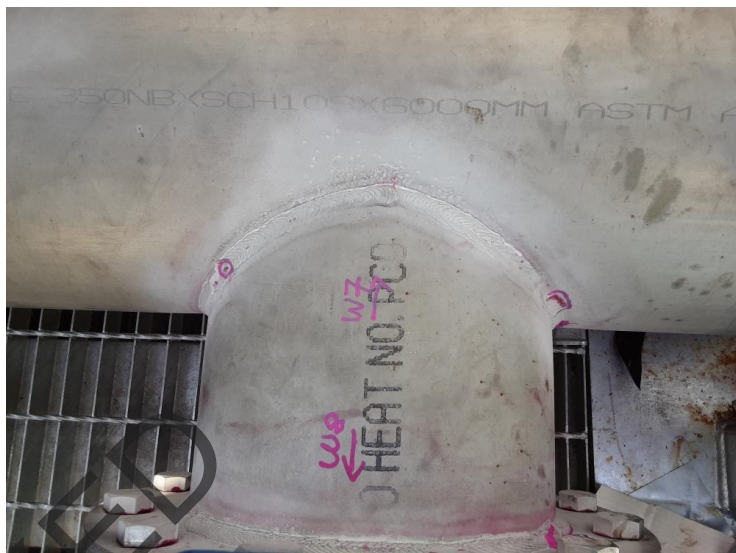
Image 10 of 12 - South end spool #1 W7-8

| Identification | Spool No. | Weld No. | Description | Test area | Discontinuities |
|---|---|---|---|---|---|
| South end | Spool 1 | 7 | Bottom header | 7-5 o'clock Facing west | LS25 @ 2ocl, LS30 @ 3ocl, CC5 @ 5ocl, LS25 @ 6ocl, CC5 @ 11ocl |
| South end | Spool 1 | 8 | Bottom header | 7-5 o'clock Facing east | LS20 @ 10ocl |

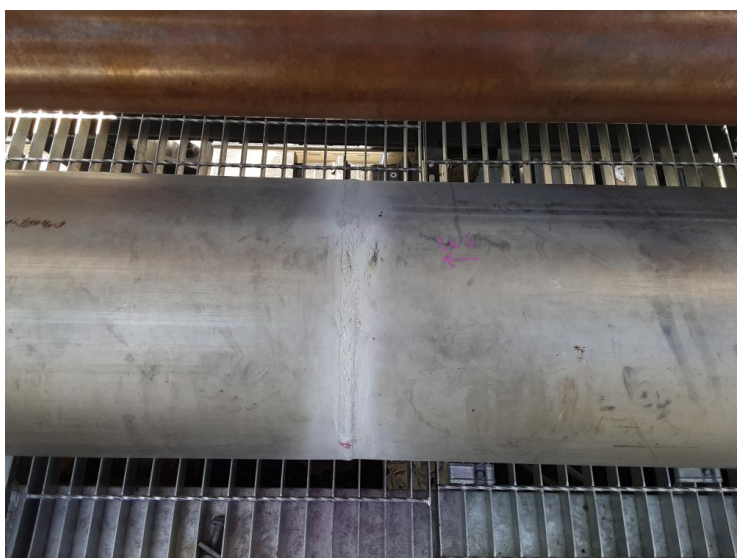
Image 11 of 12 - South end spool #1 W6

| Identification | Spool No. | Weld No. | Description | Test area | Discontinuities |
|---|---|---|---|---|---|
| South end | Spool 1 | 6 | Bottom header | 7-5 o'clock Facing north | CC2 @ 9ocl, CC5 @ 6ocl, LS25 @ 6ocl |

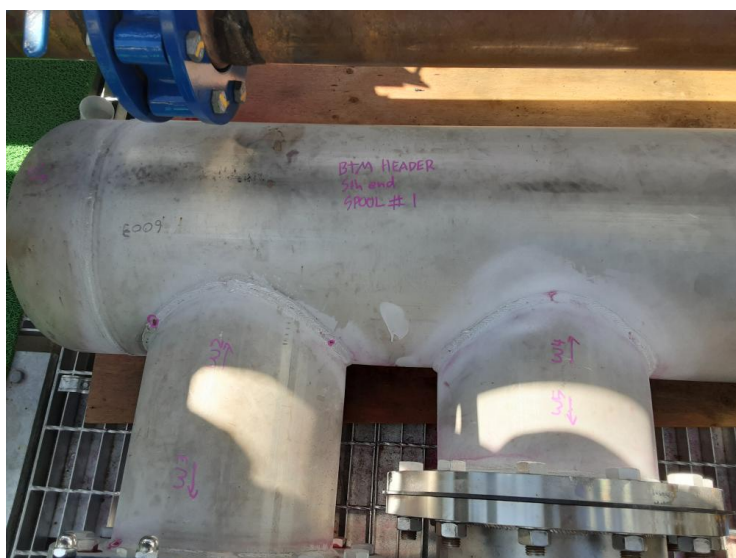
Image 12 of 12 - South end spool #1 W1-5

| Identification | Spool No. | Weld No. | Description | Test area | Discontinuities |
|---|---|---|---|---|---|
| South end | Spool 1 | 1 | Bottom header | 7-5 o'clock Facing north | CC5 @ 5ocl, CC @ 3ocl, CC15 @ 7ocl |
| South end | Spool 1 | 2 | Bottom header | 7-5 o'clock Facing east | LS15 @ 7ocl, CC5 @ 7ocl, IN10 @ 10ocl, GP2 @ 2ocl |
| South end | Spool 1 | 3 | Bottom header | 7-5 o'clock Facing west | CC10 @ 2ocl |
| South end | Spool 1 | 4 | Bottom header | 7-5 o'clock Facing east | LS20 @ 6ocl, CC5 @ 5ocl |
| South end | Spool 1 | 5 | Bottom header | 7-5 o'clock Facing west | LS25 @ 2ocl, CC5 @ 9ocl, LS30 @ 9ocl, LS20 @ 6ocl |
