## Penetrant test report

| Report number | LW26-0253-07 PT Rev. 1 | (This report supersedes LW26-0253-07 PT) |
| Job description | Visible dye penetrant testing on 350NB header weldments | |
| Identification | Job: VMM00120 NEXT DC M3 STAGE 2; Drawing: SDRG-B-0201-8241 | |

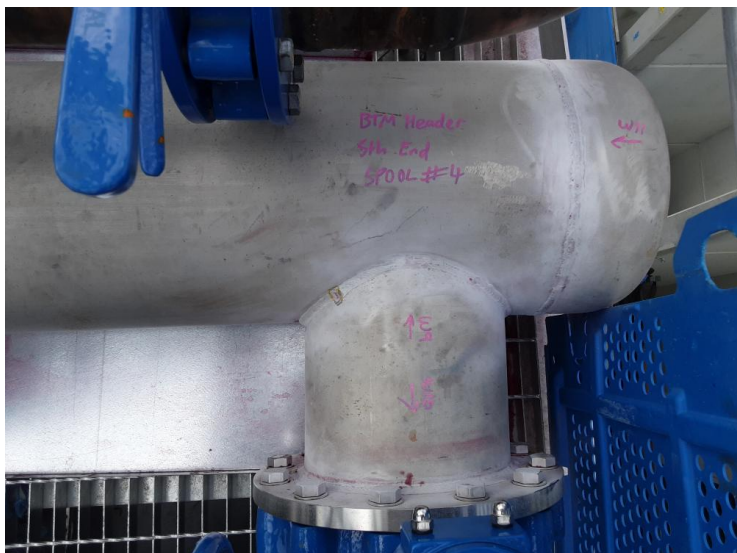
Image 1 of 6 - Bottom header South end spool #4 W9-11

| Identification | Spool No. | Weld No. | Description | Test area | Discontinuities |
|---|---|---|---|---|---|
| South end | Spool 4 | 9 | Bottom header | 7-5 o'clock Facing east | LS15 @ 11ocl, LS20 @ 6ocl, CC15 @ 7ocl |
| South end | Spool 4 | 10 | Bottom header | 7-5 o'clock Facing west | CC5 @ 12ocl, CC5 @ 12ocl, LS30 @ 3ocl, LS80 @ 6ocl, LS60 @ 7ocl, LS20 @ 9ocl |
| South end | Spool 4 | 11 | Bottom header | 7-5 o'clock Facing south | LS20 @ 3ocl, uniform porosity |

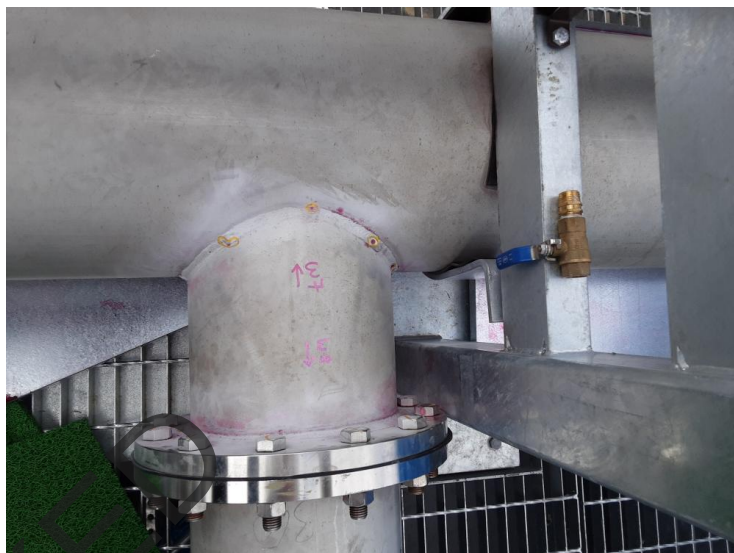
Image 2 of 6 - Bottom header South end spool #4 W7-8

| Identification | Spool No. | Weld No. | Description | Test area | Discontinuities |
|---|---|---|---|---|---|
| South end | Spool 4 | 7 | Bottom header | 7-5 o'clock Facing east | CC10 @ 1ocl, LS10 @ 12ocl, GP1 @ 3ocl, GP1 @ 3ocl, LS40 @ 4ocl |
| South end | Spool 4 | 8 | Bottom header | 7-5 o'clock Facing west | LS60 @ 6ocl, LS50 @ 7ocl, LS15 @ 3ocl, LS20 @ 1ocl, LS35 @ 9ocl |

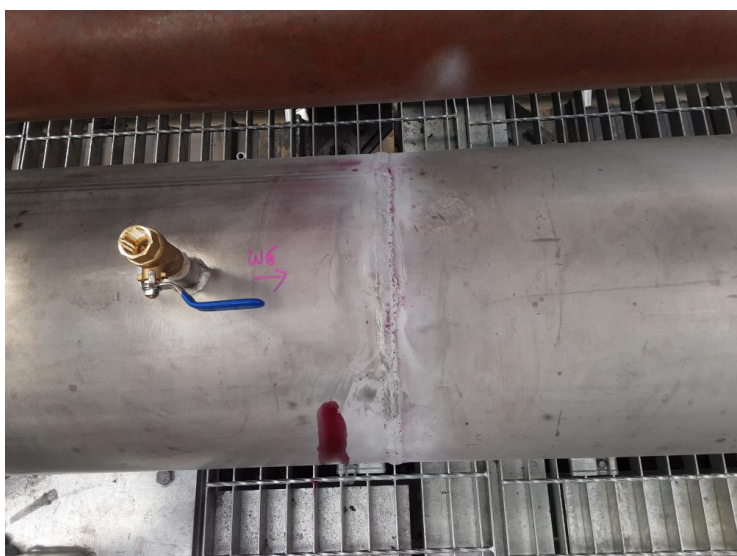
Image 3 of 6 - Bottom header South end spool #4 W6

| Identification | Spool No. | Weld No. | Description | Test area | Discontinuities |
|---|---|---|---|---|---|
| South end | Spool 4 | 6 | Bottom header | 7-5 o'clock Facing south | Uniform porosity |

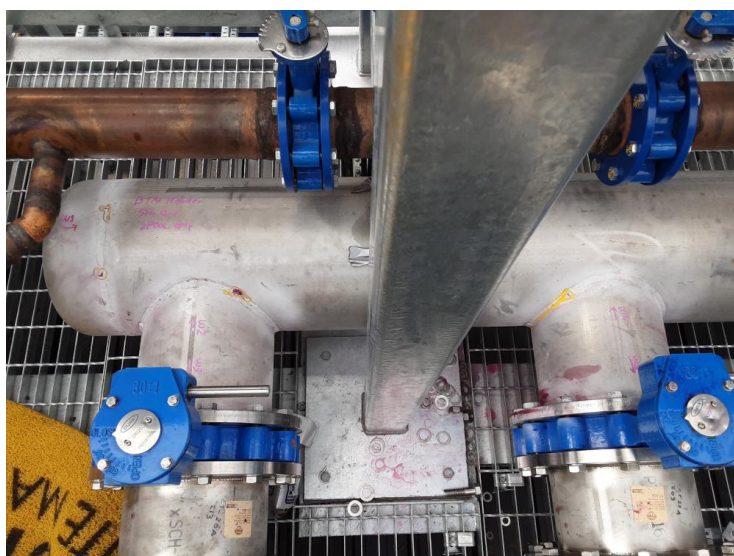
Image 4 of 6 - Bottom header South end spool #4 W1-5

| Identification | Spool No. | Weld No. | Description | Test area | Discontinuities |
|---|---|---|---|---|---|
| South end | Spool 4 | 1 | Bottom header | 7-5 o'clock Facing north | LS35 @ 12ocl, CC5 @ 2ocl, LS20 @ 4ocl, LS50 @ 6ocl, LS15 @ 7ocl, uniform porosity |
| South end | Spool 4 | 2 | Bottom header | 7-5 o'clock Facing east | LS30 @ 6ocl, LS25 @ 1ocl, LS15 @ 3ocl, uniform porosity |
| South end | Spool 4 | 3 | Bottom header | 7-5 o'clock Facing west | CC5 @ 10ocl, LS25 @ 10ocl, LS15 @ 12ocl, CC10 @ 3ocl, LS10 @ 3ocl, uniform porosity |
| South end | Spool 4 | 4 | Bottom header | 7-5 o'clock Facing east | CC10 @ 7ocl, LS10 @ 11ocl, LS30 @ 9ocl, LS25 @ 6ocl, uniform porosity |
| South end | Spool 4 | 5 | Bottom header | 7-5 o'clock Facing west | CC3 @ 12ocl, CC10 @ 12ocl, LS25 @ 12ocl, LS15 @ 3ocl, LS30 @ 5ocl, LS40 @ 8ocl, uniform porosity |

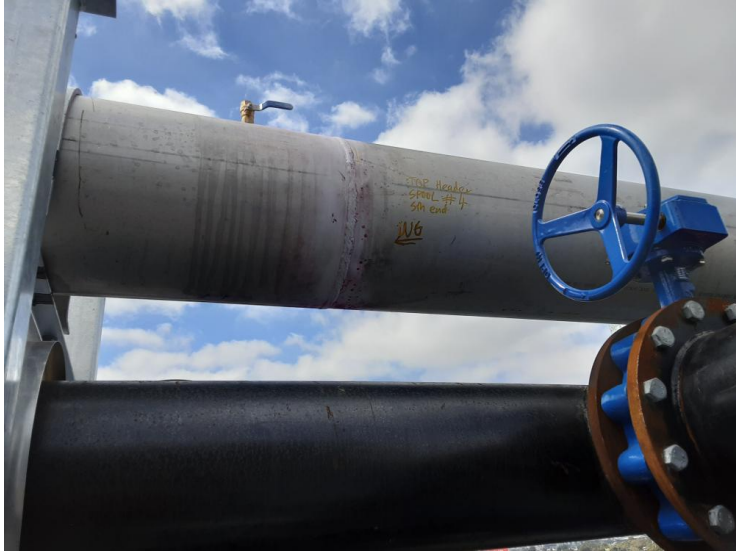
Image 5 of 6 - Top header South end spool #4 W6

| Identification | Spool No. | Weld No. | Description | Test area | Discontinuities |
|---|---|---|---|---|---|
| South end | Spool 4 | 6 | Top header | 12-7 facing south | LS15 @ 12ocl, LS30 @ 3ocl, LS30 @ 5ocl, LS100 @ 6ocl, spatter |

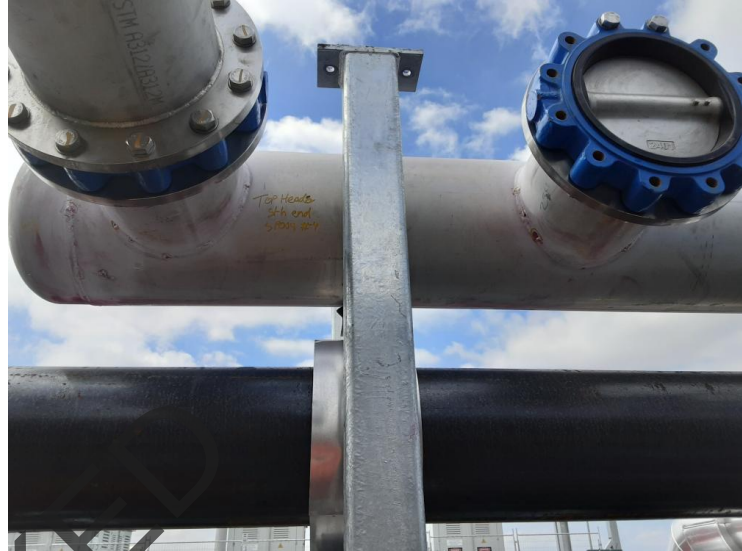
Image 6 of 6 - Top header South end spool #4 W1-5

| Identification | Spool No. | Weld No. | Description | Test area | Discontinuities |
|---|---|---|---|---|---|
| South end | Spool 4 | 1 | Top header | 6-12 o'clock Facing north | LS35 @ 9ocl, LS20 @ 8ocl, LS25 @ 7ocl, random blob of weld in PM @ position 7 possible hole repair |
| South end | Spool 4 | 2 | Top header | Entire facing east | CC5 @ 1ocl, LS15 @ 9ocl, LS20 @ 8ocl, LS20 @ 6ocl, LS10 @ 7ocl |
| South end | Spool 4 | 3 | Top header | Entire facing west | LS5 @ 11ocl, LS20 @ 3ocl |
| South end | Spool 4 | 4 | Top header | Entire facing east | LS10 @ 2ocl, SSX15 @ 3ocl, LS15 @ 5ocl, LS15 @ 8ocl, LS20 @ 9ocl, LS20 @ 9ocl |
| South end | Spool 4 | 5 | Top header | Entire facing west | LS25 @ 9ocl, LS20 @ 6ocl, LS15 @ 3ocl |
