## Penetrant test report

**Report number** LW26-0253-01 PT  
**Customer name** AAS STEEL PTY LTD  
**Address** 9 Trade Place Pakenham VIC Australia 3810  
**Requested by** Shan Senn

**Job description** Visible dye penetrant testing on 350NB header weldments  
**Identification** Job: VMM00120 NEXT DC M3 STAGE 2; Drawing: SDRG-B-0201-8241

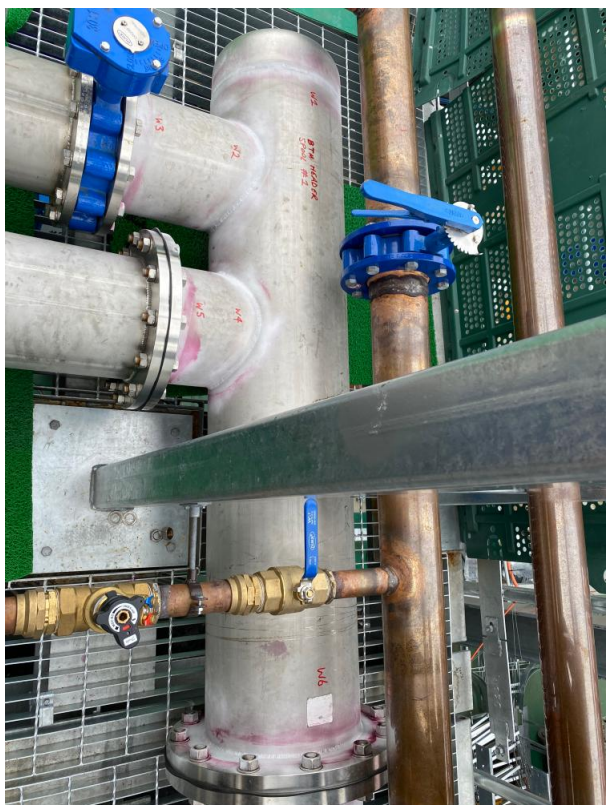
Image 1 of 13 - Bottom header spool 1- north end

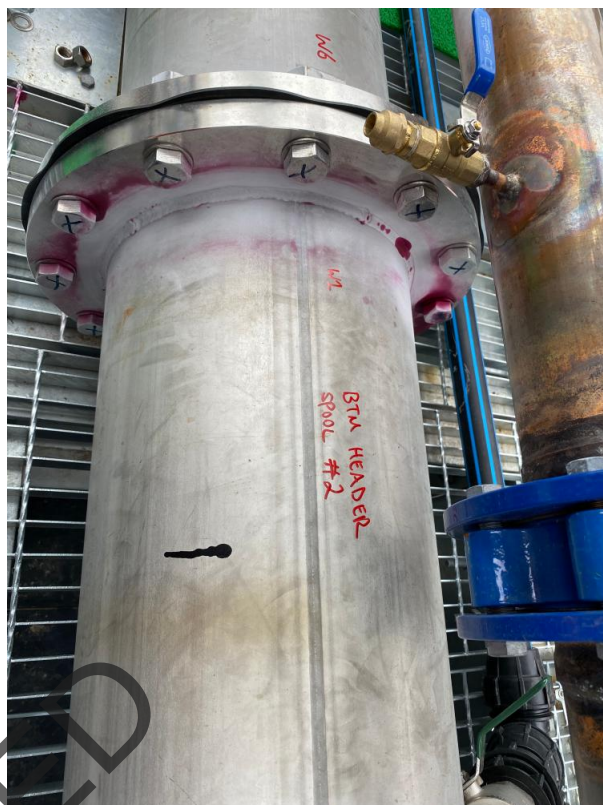
| Identification | Spool No. | Weld No. | Description | Discontinuities |
|---|---|---|---|---|
| North end | Spool 2 | 1 | Bottom header | Linear porosity/ overlap/ lack of fusion at 12-5 o'clock position when facing north |

Image 2 of 13 - Bottom header spool 2 W1

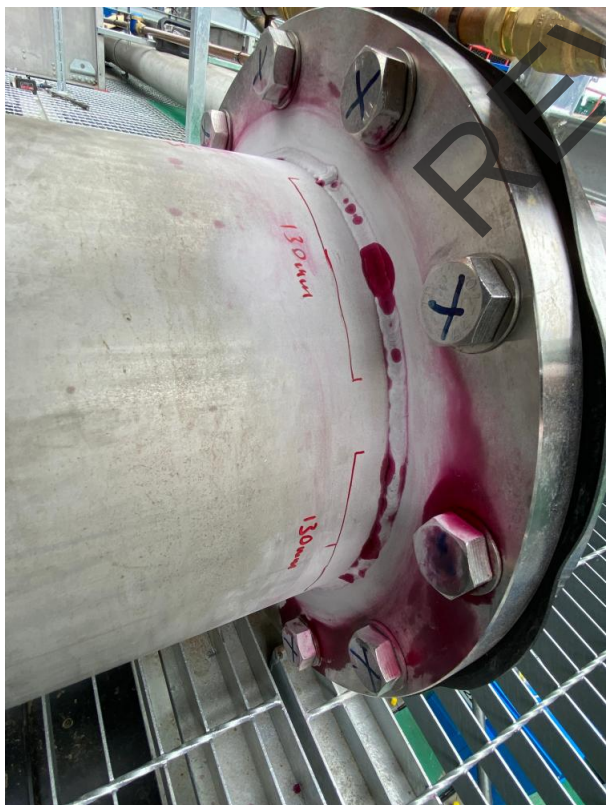
Image 3 of 13 - Spool 2 W1- 130mm linear porosity

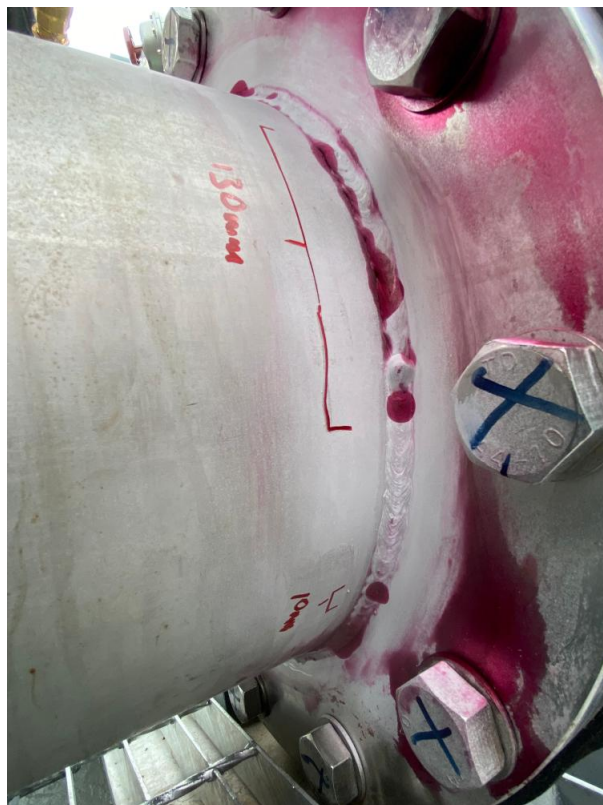
Image 4 of 13 - Spool 2 W1- 130mm overlap/ lack of fusion; 10mm porosity

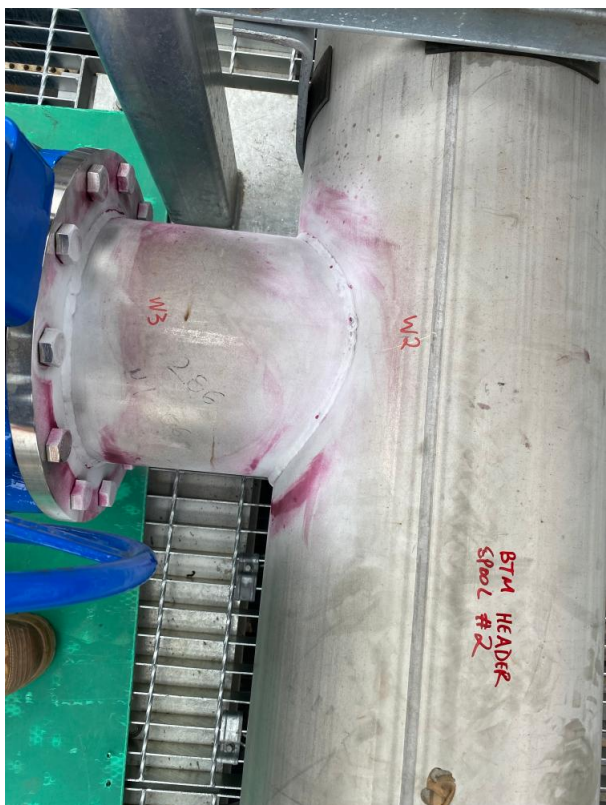
| Identification | Spool No. | Weld No. | Description | Discontinuities |
|---|---|---|---|---|
| North end | Spool 2 | 2 | Bottom header | Porosity at 3-4, 11, and 12 o'clock position when facing east |
| North end | Spool 2 | 3 | Bottom header | Overlap at 9 o'clock position when facing west |

Image 5 of 13 - Bottom header spool 2 W2 & W3

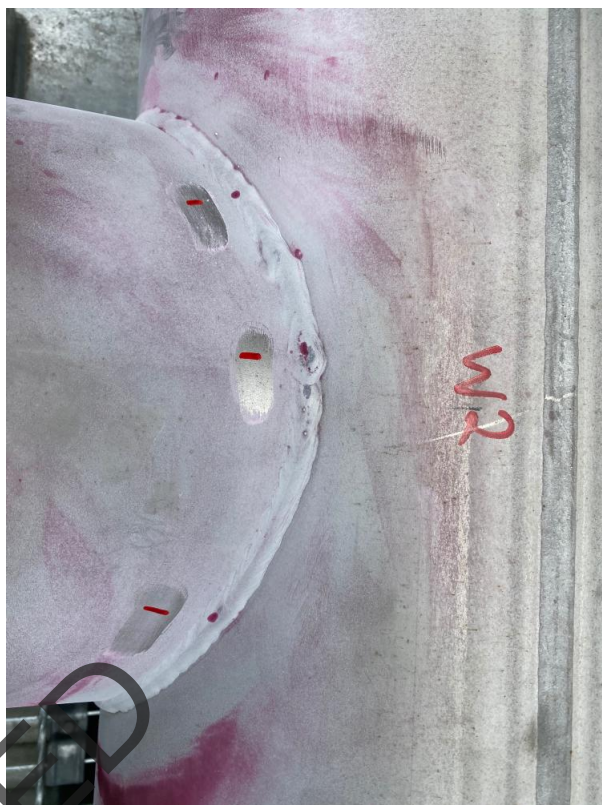
Image 6 of 13 - Spool 2 W2- 5mm porosity x 3

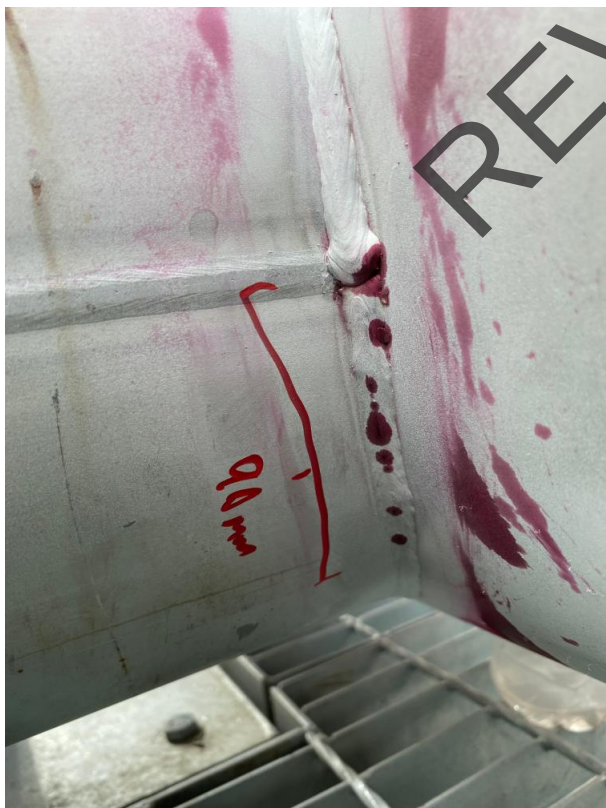
Image 7 of 13 - Spool 2 W2- 90mm linear porosity & poor stop/start

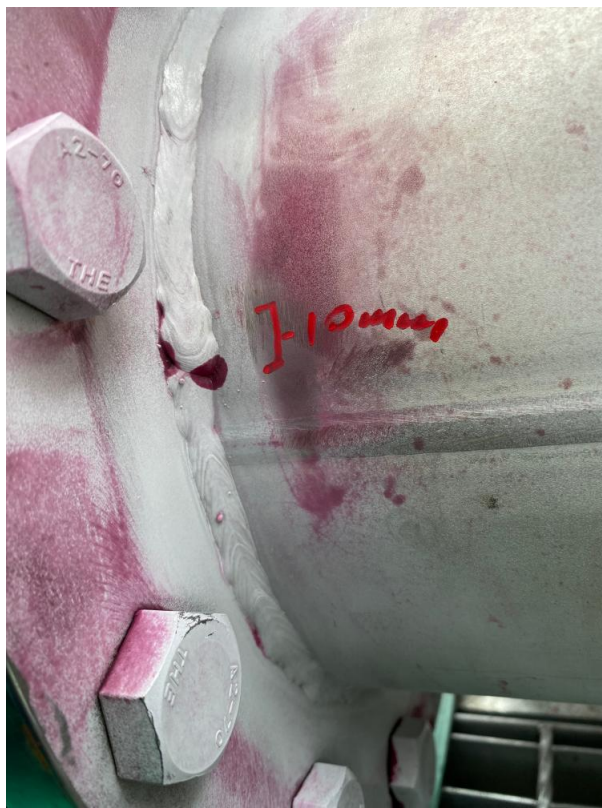
Image 8 of 13 - Spool 2 W3- 10mm overlap & poor stop/start

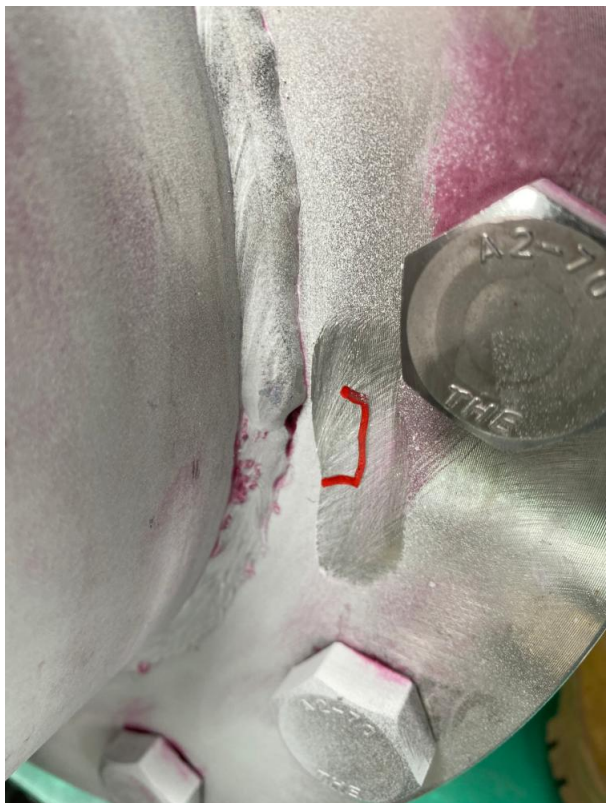
Image 9 of 13 - Spool 2 W3- 7mm overlap

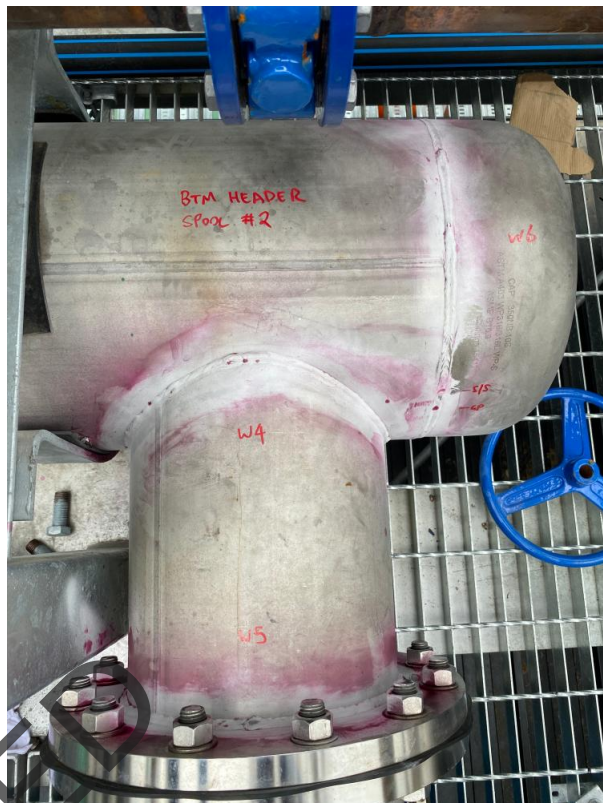
Image 10 of 13 - Bottom header spool 2 W4, W5 & W6

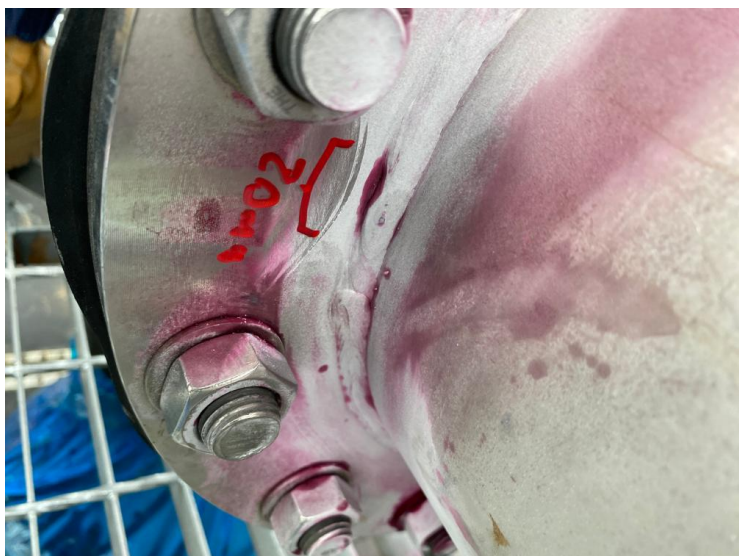
| Identification | Spool No. | Weld No. | Description | Discontinuities |
|---|---|---|---|---|
| North end | Spool 2 | 5 | Bottom header | Lack of fusion at 9 o'clock position when facing west |

Image 11 of 13 - Spool 2 W5- 20mm overlap/ lack of fusion

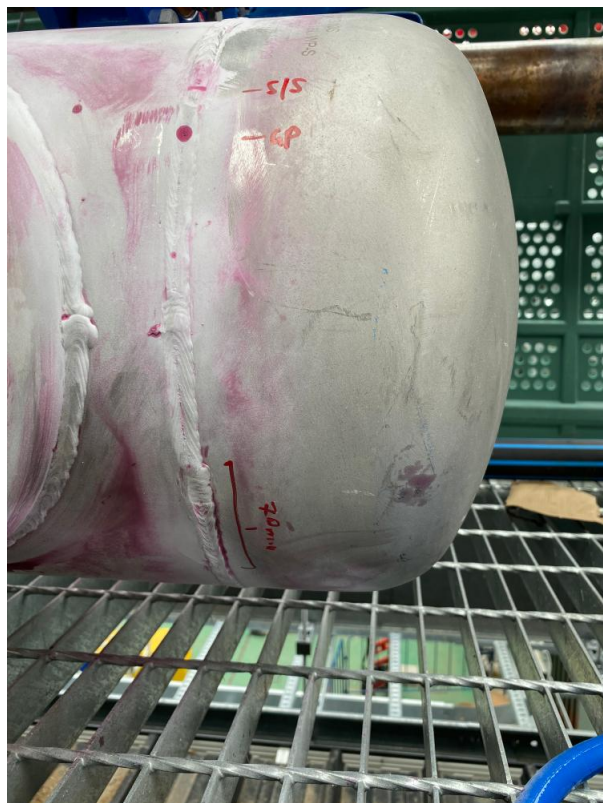
| Identification | Spool No. | Weld No. | Description | Discontinuities |
|---|---|---|---|---|
| North end | Spool 2 | 6 | Bottom header | Porosity at 9 o'clock position, overlap at 4 o'clock and 7-8 o'clock position when facing north |

Image 12 of 13 - Spool 2 W6- 70mm overlap/ lack of fusion; 10mm poor restart; 10mm porosity

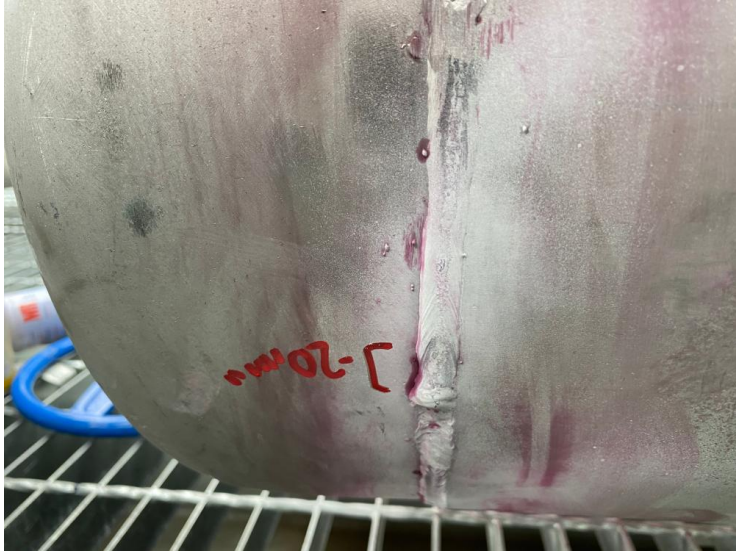
Image 13 of 13 - Spool 2 W6- 20mm overlap/ lack of fusion
