## Eddy current test report

| <b>Report number</b> | NC25-0994-05 ET |
| <b>Job description</b> | Steril Koni Mobile Column Lift Structural Welds |
| <b>Identification</b> | Serial no:-TX172203 Model: ST-1073 FWF Type:- 34408054-02 |

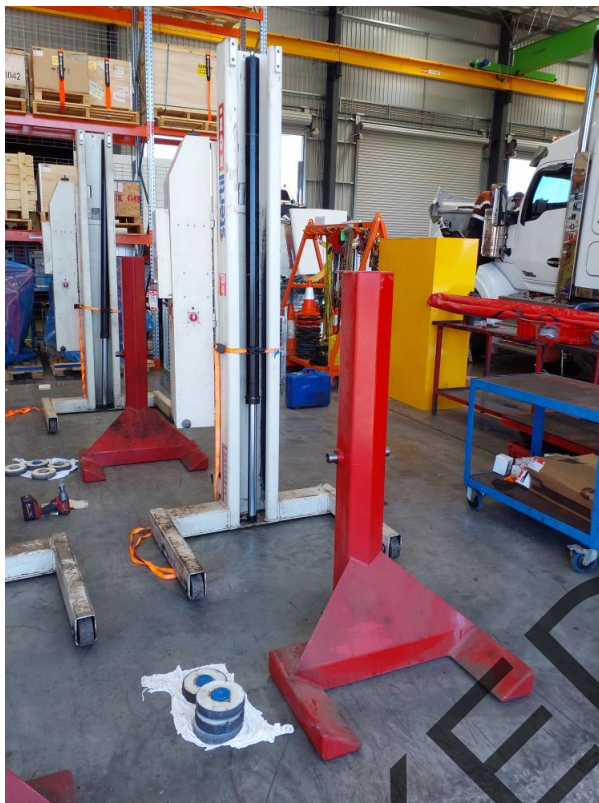
| Identification | Test area | Discontinuities | Result |
|---|---|---|---|
| Column | 100% of accessible structural welds | No cracks detected | C |
| Lifting jib | 100% of accessible structural welds | No cracks detected | C |

Image 1 of 2 - General view of the test area
