## Weld qualification test report

| Report number | LP26-1318-02 WPWQ |
| Description | Welder qualification testing |
| Joint type | Fillet - Tee Fillet |

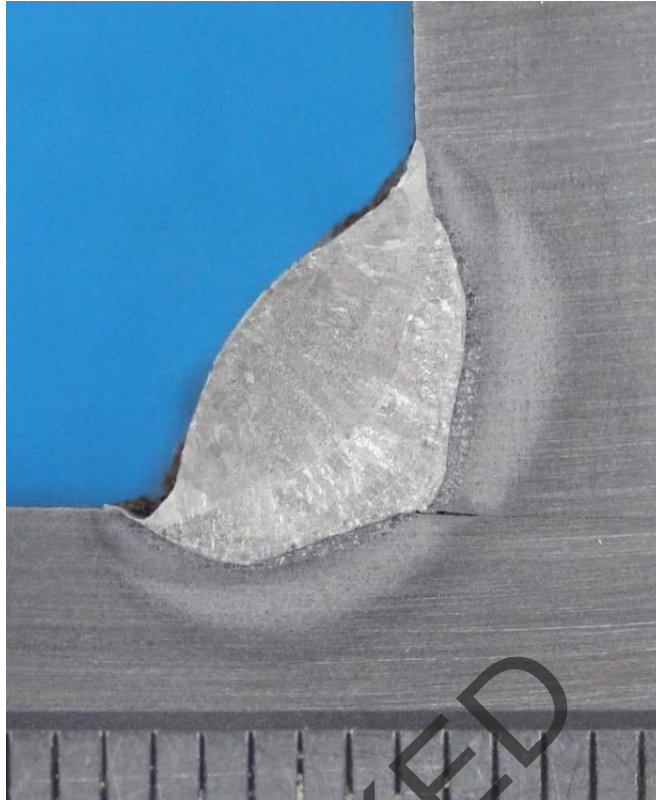
| <b>Leg length</b> | 7.1 mm, 5.6 mm |
| <b>Discontinuities</b> | Nil |
| <b>Comments</b> | The etched cross-section showed complete penetration and fusion with no evidence of cracks, gross porosity or inclusions. |
| <b>Test results</b> | The test results comply with the specification requirements. |

Image 1 of 2 - Macro Specimen 1 (1 Graduation = 1mm) M1

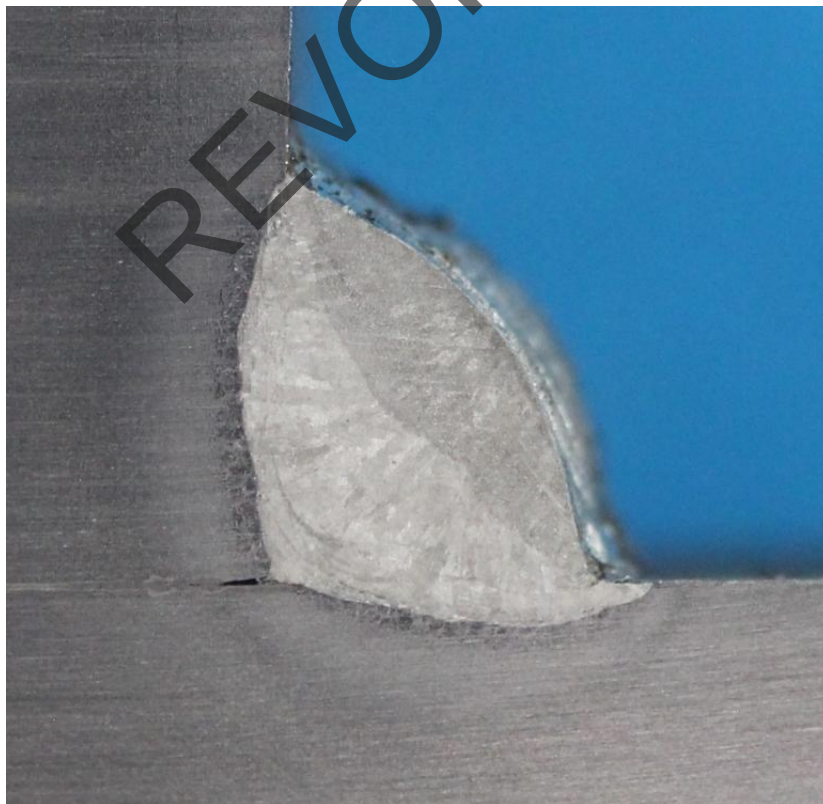
| <b>Leg length</b> | 6.4 mm, 5.35 mm |
| <b>Throat thickness</b> | 4.2 mm |
| <b>Discontinuities</b> | Nil |
| <b>Comments</b> | The etched cross-section showed complete penetration and fusion with no evidence of cracks, gross porosity or inclusions. |
| <b>Test results</b> | The test results comply with the specification requirements. |

Image 2 of 2 - Macro Specimen 2 (1 Graduation = 1mm) M2
