## Weld qualification test report

| Report number | LP26-1523-03 WPWQ |
| Description | Welder qualification testing |
| Joint type | Fillet weld - single pass |

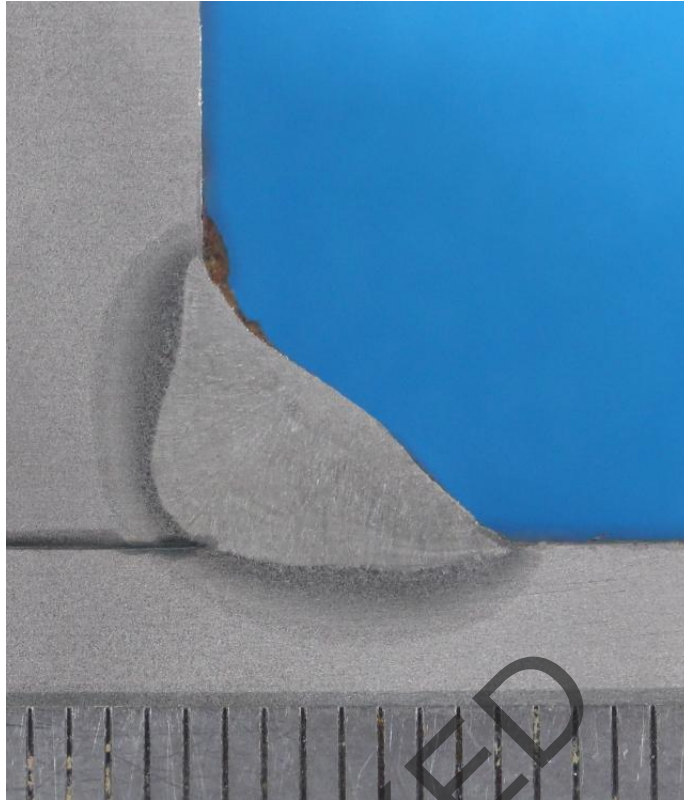
| Leg length | 6.7 mm, 8.0 mm |
| Throat thickness | 5.0 mm |
| Comments | The etched cross-section showed complete penetration and fusion with no evidence of cracks, gross porosity or inclusions. |
| Test results | The test results comply with the specification requirements. |

Image 1 of 2 - Macro Specimen 1 ( 1 Graduation = 1mm) M1

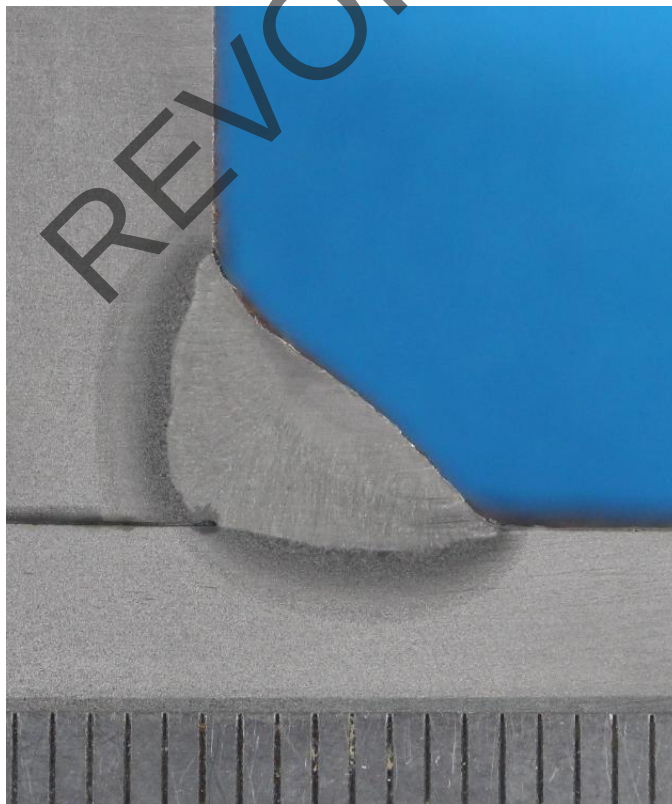
| Leg length | 6.3 mm, 7.5 mm |
| Throat thickness | 4.7 mm |
| Comments | The etched cross-section showed complete penetration and fusion with no evidence of cracks, gross porosity or inclusions. |
| Test results | The test results comply with the specification requirements. |

Image 2 of 2 - Macro Specimen 2 ( 1 Graduation = 1mm) M2 stop/start
