## Magnetic particle test report

**Report number** LW25-1782-01 MT  
**Customer name** FUSION-WELD ENGINEERING PTY LTD  
**Address** 1865 Frankston Flinders Road Hastings VIC Australia 3915

**Job description** MT of Vessel Welds  
**Identification** Refer to Table below  
**Material grade** Stainless Steel 316S, ASTM A516/516M - Grade 70  
**Test specification** AS 4037 -1999 (R 2016) - Sec. 8 (AS 1210 - 2010 Class 1 PV) - NDT, AS 4037 -1999 (R 2016) - Sec. 8 (AS 1210 - 2021 Class 2A PV) - NDT

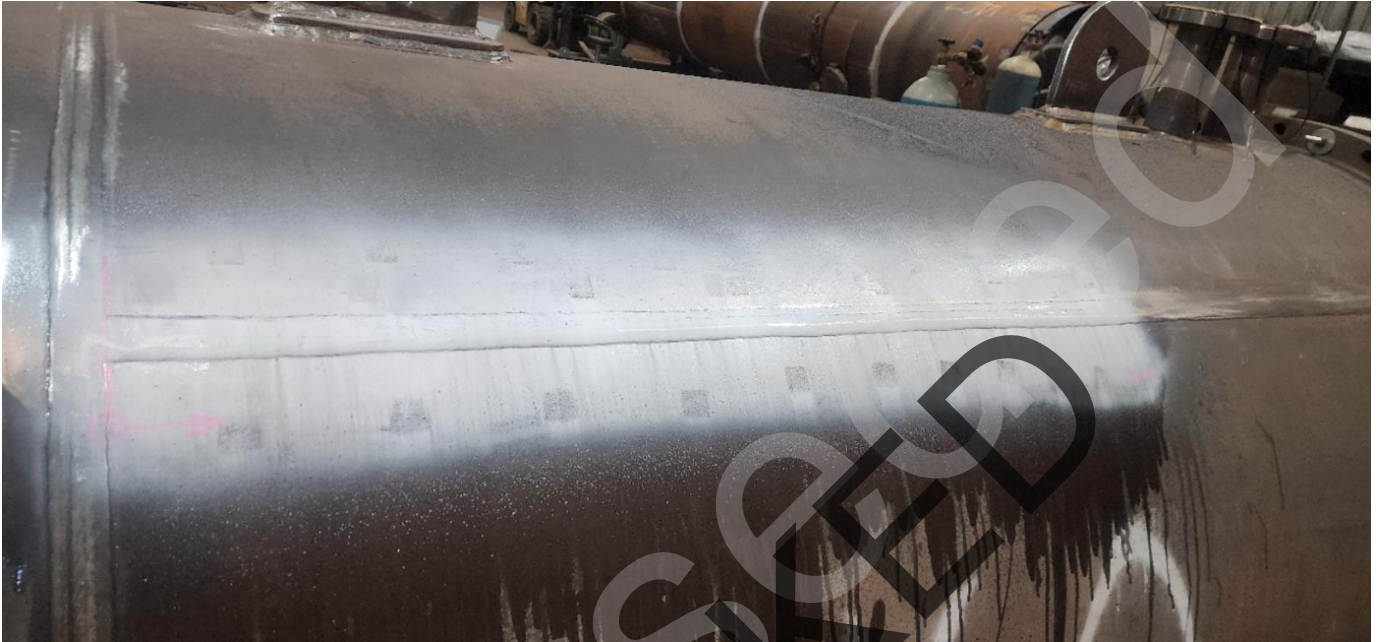
Identification	Drawing No.	Weld No.	Description	Test area	Discontinuities	Result
Vessel number: 420XS20160	420M(2D)25027	L2	U2 Fresh Cleaning Caustic Heater	1000mm of weld as pictured, datum at centre circ weld	NUSID	C

Image 1 of 1 - General view of the test area
