## Ultrasonic test report

| Report number | NC25-0994-06 UT |
| Job description | Stertil Koni Mobile Column Lift Pins |
| Identification | Serial no:-TX172202 Model: ST-1073 FWF Type:- 34408054-02 |

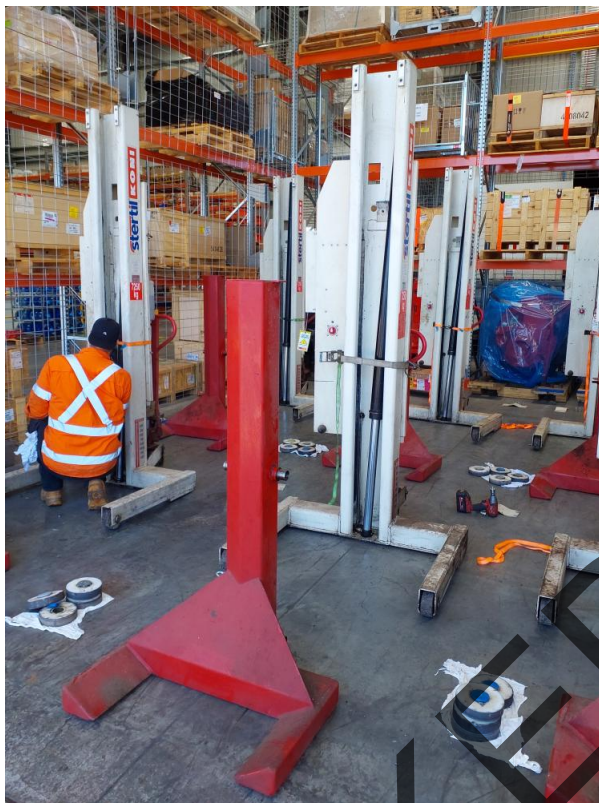
Image 1 of 2 - General view of the test area

| Identification | Quantity | Discontinuities | Result |
|---|---|---|---|
| Wheel pins | 2 | No cracks detected | C |
