Magnetic particle test report

Report number LA26-0198-01 MT
Customer name Leed Steel Pty Ltd
Address 513 Atkins Street Albury NSW Australia 2640
Requested by John Turner
Purchase Order TBA
Accredited laboratory LMATS Albury Laboratory
Test date 11/05/2026
Job address 513 Atkins Street Albury NSW Australia 2640
Job description MT inspection of welds on structural components
Identification Job #2071
Material grade Carbon steel
Test specification AS/NZS 1554.1:2014 - Cl.6.2.2 Cat SP - NDT on welds
Acceptance criteria AS/NZS 1554.1:2014 - Cl.6.2.2 Cat SP - NDT on welds
Test method AS 1171 - 1998 (Reconfirmed 2022)-MT - colour contrast
Test procedure TP-MT-01 (I1, R9)
Test type Wet colour contrast (visible)
Viewing condition Visible colour contrast (non-fluorescent)
Magnetization Magnetic flow method - AC yoke
Test area Weld & associated HAZ surface only
Surface condition As welded
Equipment L006894 Huatec HCDX-Y2 MT Yoke, L004852 NDT Equipment sales SB0023 MT Calibration block, L004842 Digital lux meter White light meter Light meter

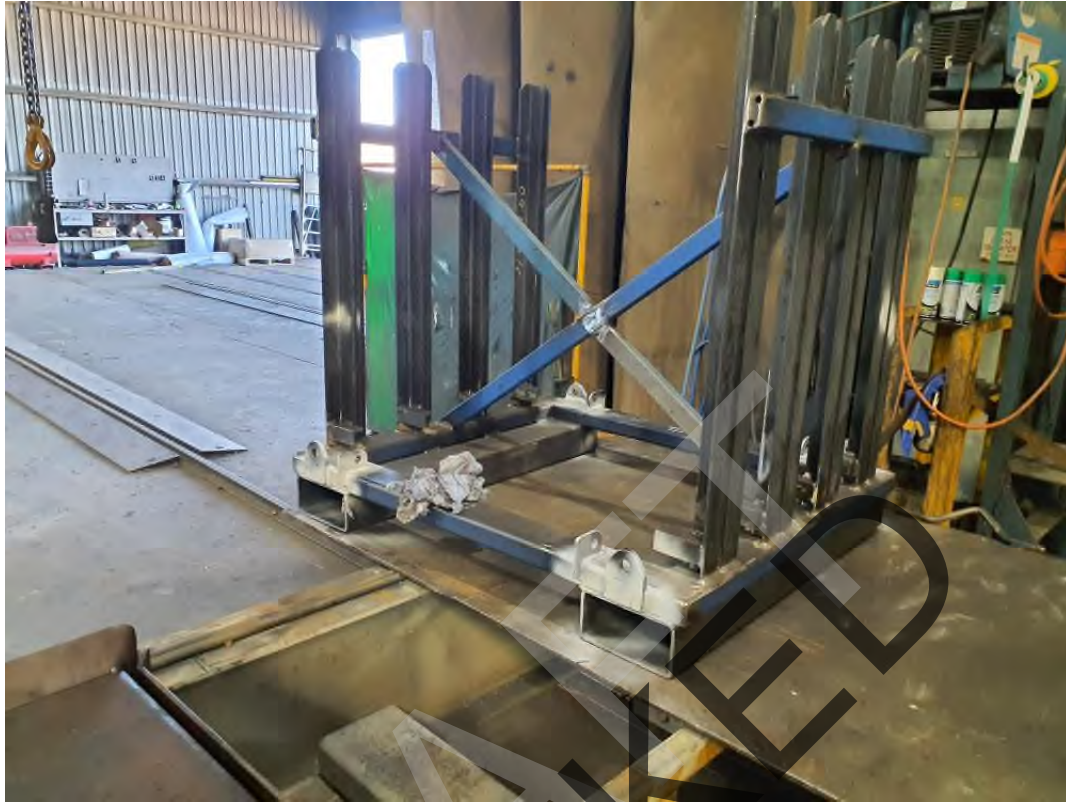
Image 1 of 4 - General view of the test area

Identification	Description	PQR/WPS No.	Welder name (ID)	Discontinuities	Result
03-101	10% of welds on item (refer to drawing)	LS010, LS012A	Shane Sard, Phil Heir	NUSID	C
02-101	10% of welds on item (refer to drawing)	LS010, LS012A	Shane Sard, Phil Heir	NUSID	C
02-201	10% of welds on item (refer to drawing)	LS010, LS012A	Shane Sard, Phil Heir	NUSID	C
05-101	10% of welds on item (refer to drawing)	LS010, LS012A	Shane Sard, Phil Heir	NUSID	C
04-101	10% of welds on item (refer to drawing)	LS010, LS012A	Brad Jupp, Phil Heir	NUSID	C
