## Weld qualification test report

| Report number | LP26-0601-05 WPWQ Rev. 2 | (This report supersedes LP26-0601-05 WPWQ Rev. 1) |
| WPQR No. | AGE-WPQR-FW001 | |
| Joint type | Fillet weld - single pass | |

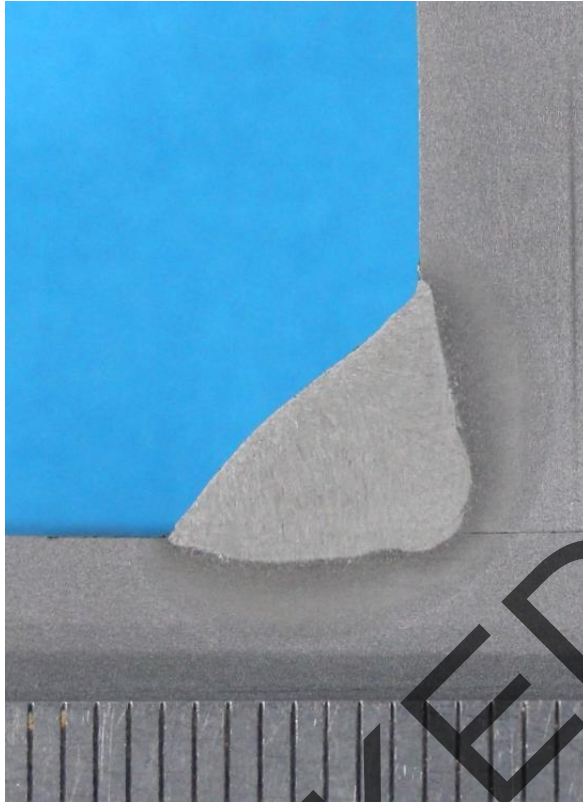
Image 1 of 1 - Macro Specimen 1 Single Pass

| Leg length | 7.5 mm, 7.2 mm |
| Throat thickness | 5.1 mm |
| Discontinuities | Nil |
| Comments | The etched cross-section showed complete penetration and fusion with no evidence of cracks, gross porosity or inclusions. |
| Test results | The test results comply with the specification requirements. |
